# LONG-RANGE FACILITY PLAN 2020

## AMITY SCHOOL DISTRICT

By IBI Group Architects, Inc.

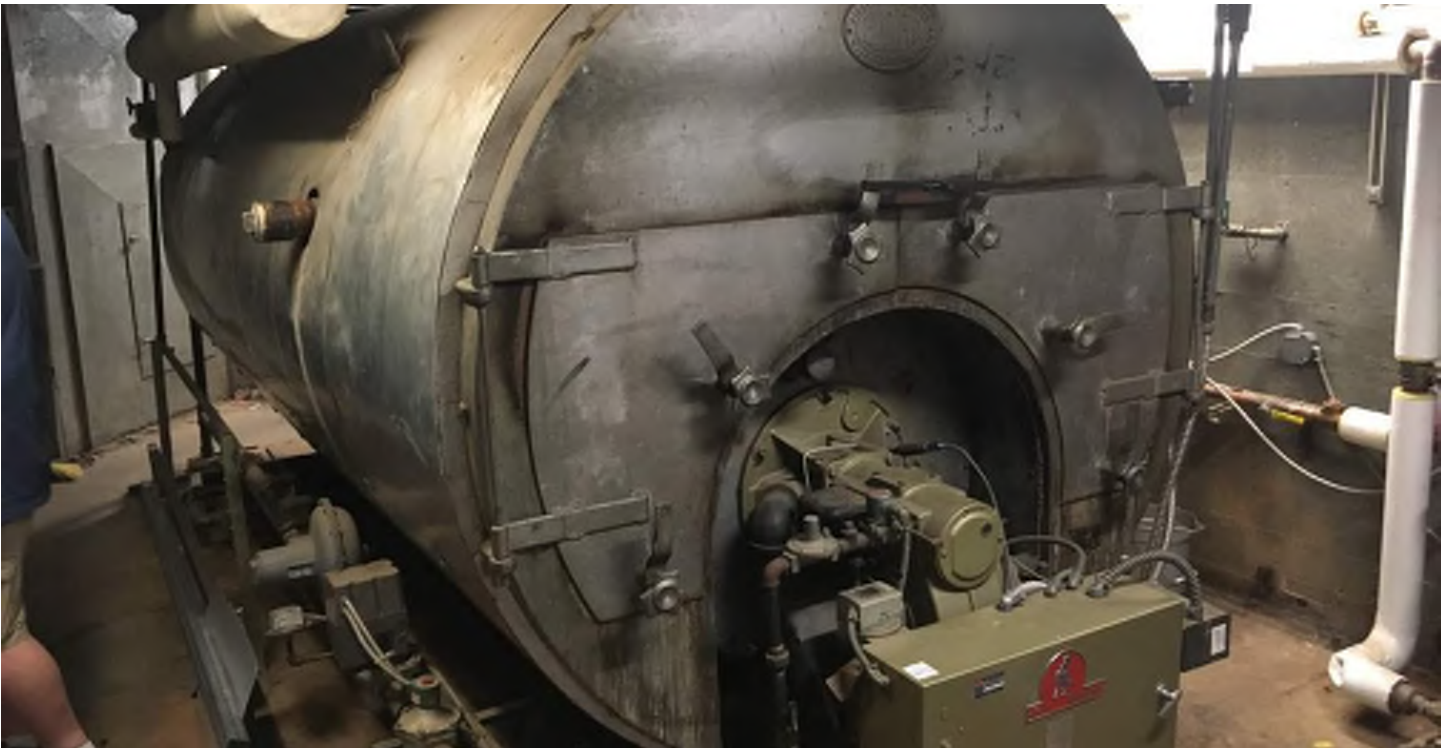
■ Middle School Boiler, circa 1930's

- New security vestibule
- Office remodel to include health room
- New counseling center
- New HVAC system, boiler replacement
- Electrical system upgrades
- Plumbing upgrades – drinking fountains esp.
- New classrooms for the arts – music, drama, fine art
- New STEM labs and hands-on learning opportunities
- New gymnasium / multipurpose addition
- Upgrade outdated science labs
- Replace aging furniture
- Upgrade PA system to cover all areas of the building and outside
- Upgrade aging locker rooms
