# FACILITY CONDITION ASSESSMENT

Lake Oswego School District

May 2021

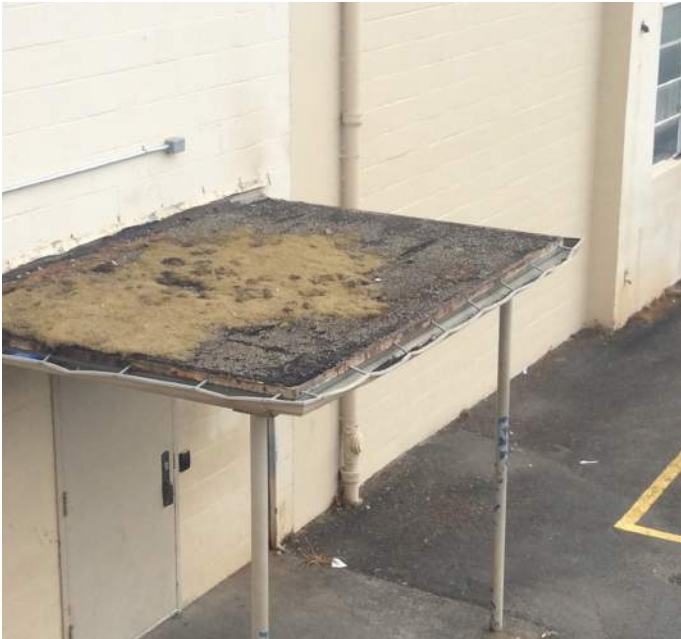
CANOPY TO BE REMOVED

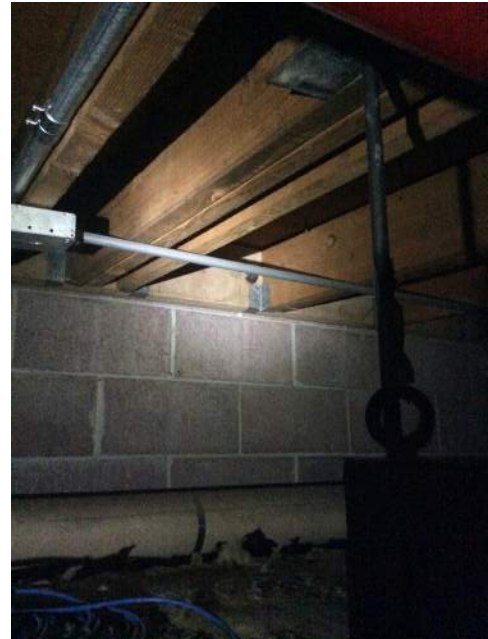
INADEQUATE DIAPHRAGM CONNECTION

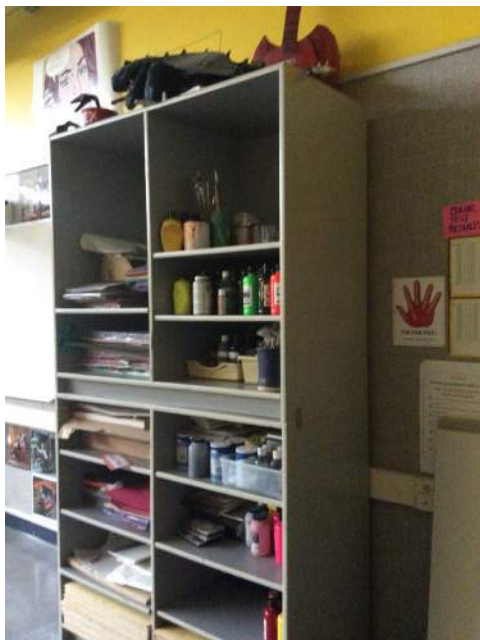
FALL PRONE CONTENTS

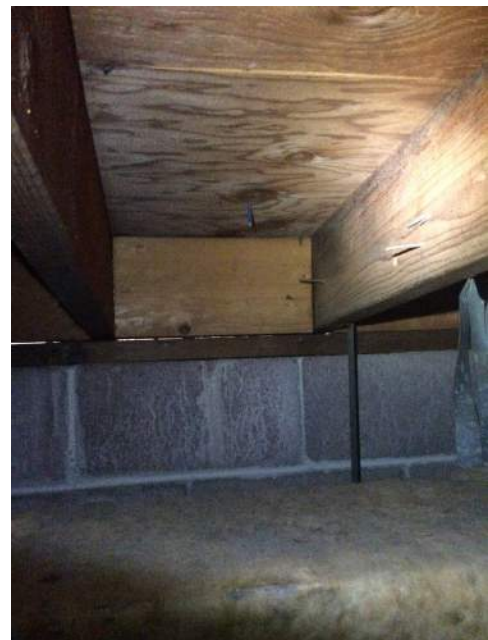
INADEQUATE JOIST CONNECTION

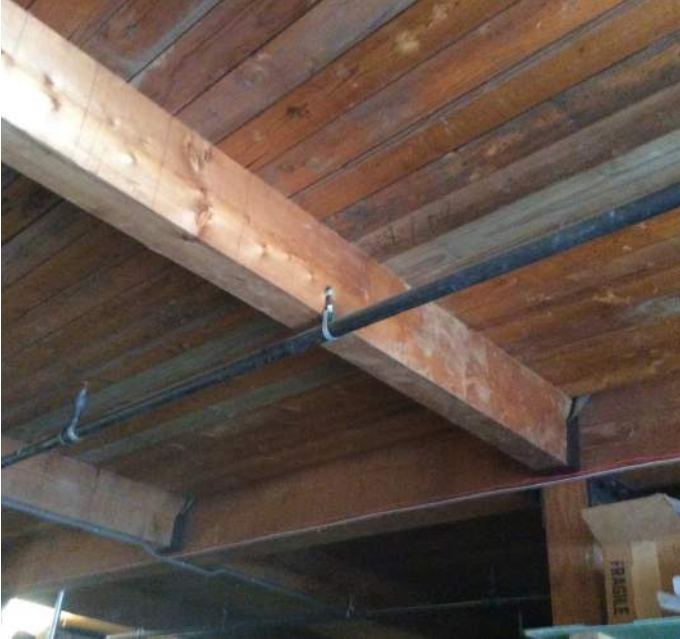
REMOVE STRAIGHT SHEATHING

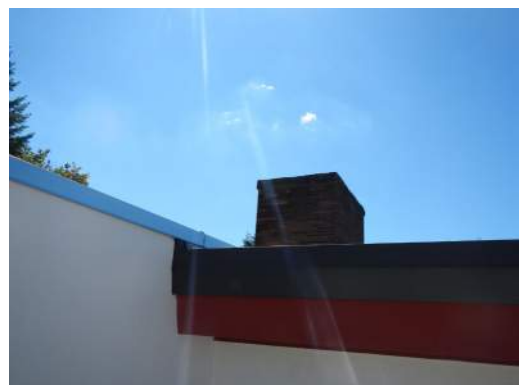
URM CHIMNEY

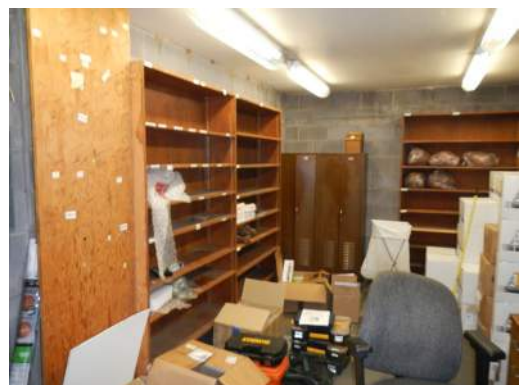
UNBRACED SHELVING
