# EDUCATIONAL ADEQUACY AND CAPACITY ANALYSIS

**Eagle Point School District**

**IBI GROUP**

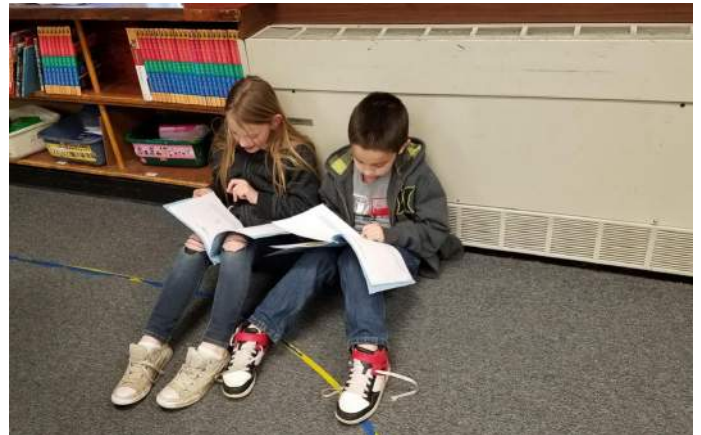
The main elementary school building was built in 1935 and has challenges inherent to schools of that era. Accessibility challenges in administrative offices, wall and floor materials are aged and damaged, ventilation is poor, classrooms are small and inconsistent sizes, and there are issues in the building envelope (exterior walls and roof). There are acoustic challenges in the elementary school from loud window air conditioner units and from the nearby busy roads. There is good daylight in all classrooms in all buildings, but the elementary school classroom blinds are broken, allowing afternoon glare to come into the classroom.

As a newer school the sixth through eighth building has fewer challenges with the exception of sound leaking between classrooms where the operable walls are located. The operable walls are rarely opened and should be removed and replaced with a fully acoustic separation wall.
