# FACILITY CONDITION ASSESSMENT

Lake Oswego School District

May 2021

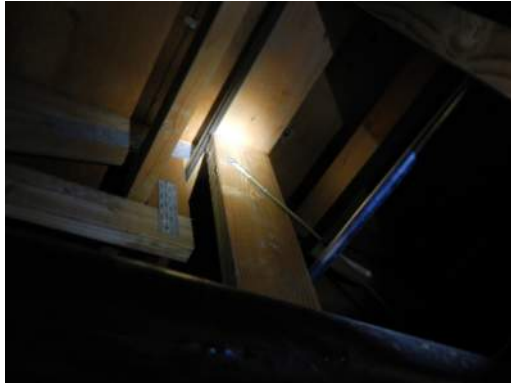
- Some roof truss top chords are continuing over and bearing on the stud wall top plates with no positive connection, and the bottom chords have been cut to allow the wall to travel through. The bottom chord should be connected with strapping. These roof trusses cover 4,400 sf at an estimated repair cost of \$5/sf

DISCONTINUOUS BOTTOM CHORD OF TRUSS

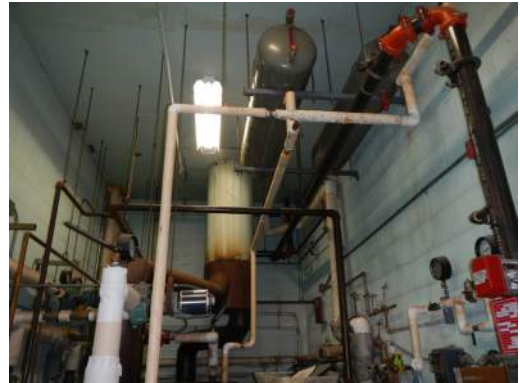
UNBRACED PIPING

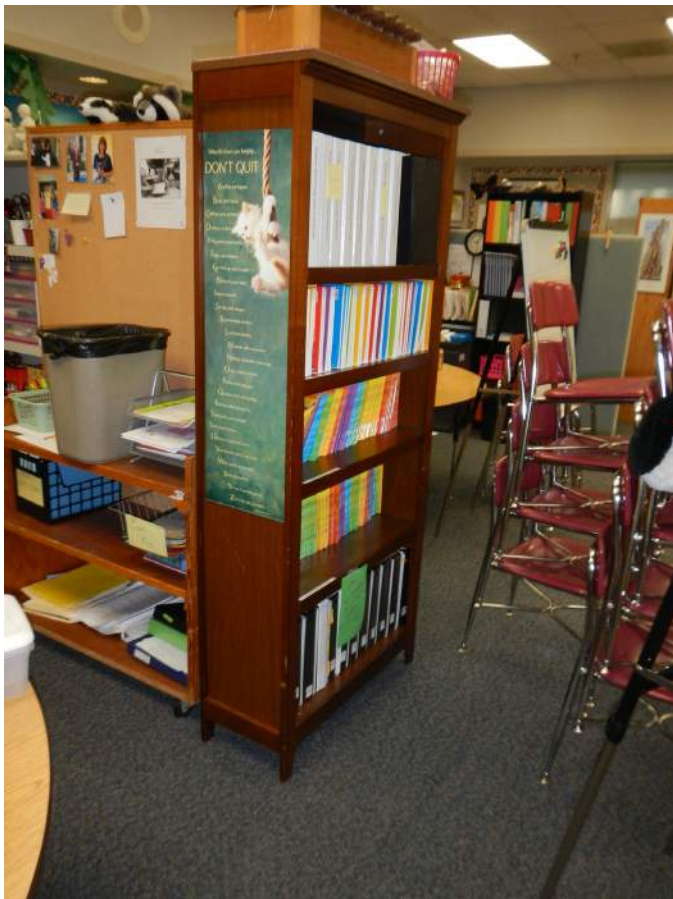
FALL PRONE SHELVEING

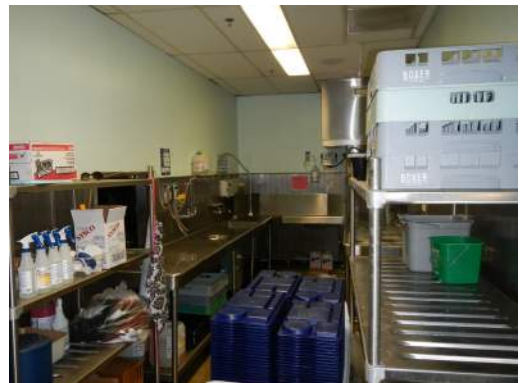
KITCHEN – FALL PRONE CONTENTS

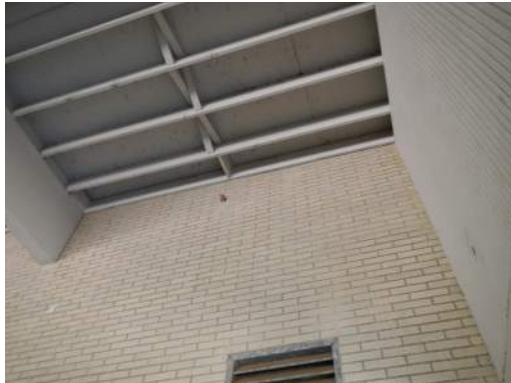
UNKNOWN DIAPHRAGM CONNECTION

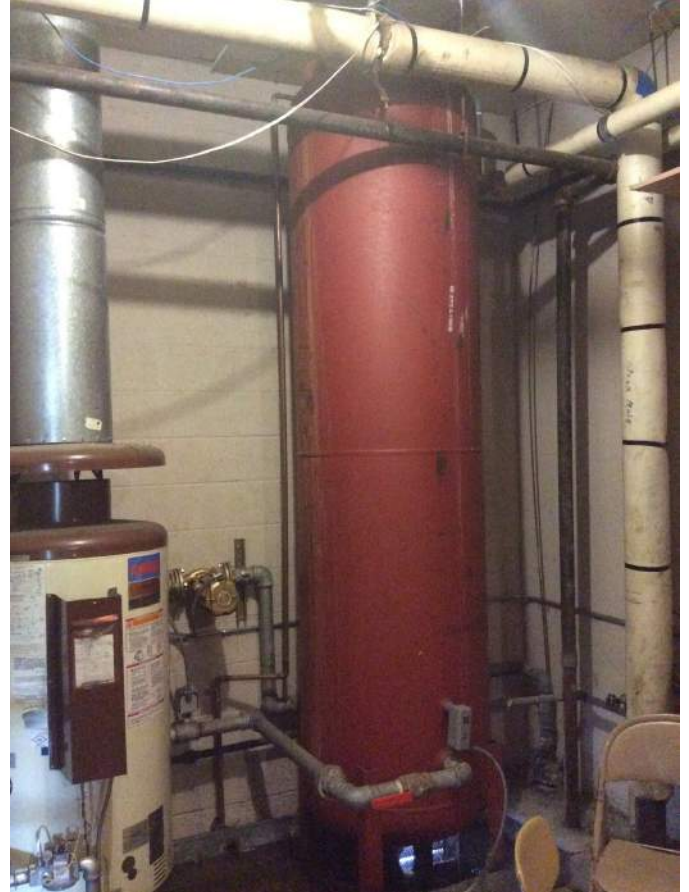
TANK TO BE BRACED FROM WALL

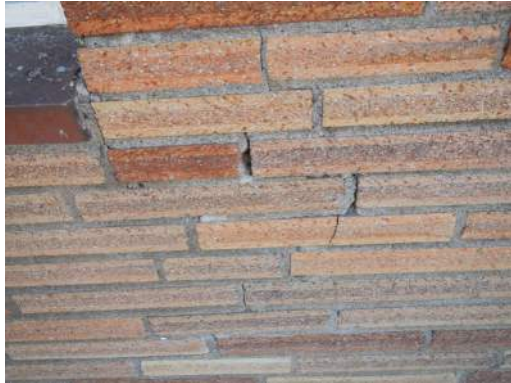
- Cracking in exterior brick veneer. This could cause deterioration of exterior wood structural panels if they exist. Reference the architectural portion of the cost estimate for extents

CRACKING IN BRICK VENEER

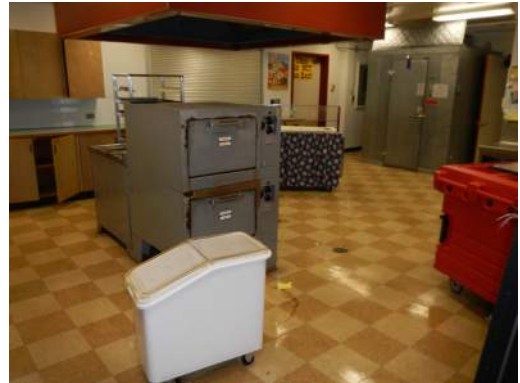
UNANCHORED EQUIPMENT IN KITCHEN

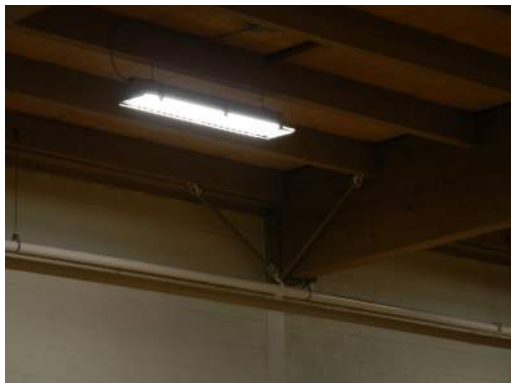
CROSS-GRAIN BENDING INDUCED IN JOIST

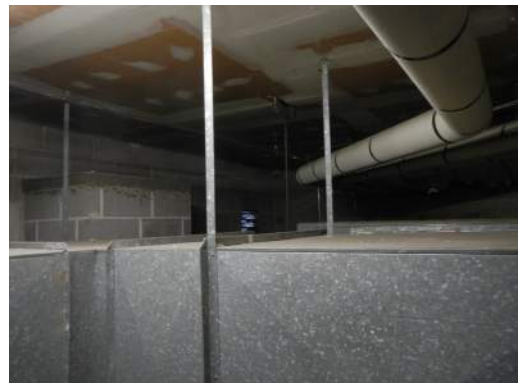
UNBRACED PIPING

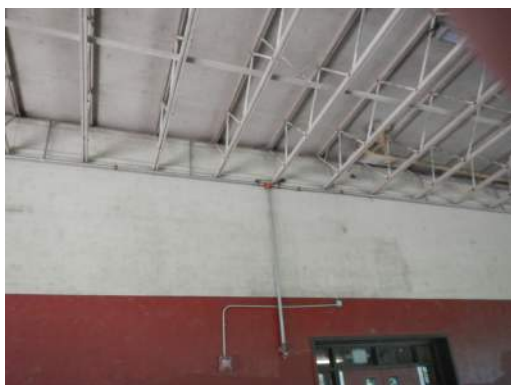
INADEQUATE DIAPHRAGM CONNECTION

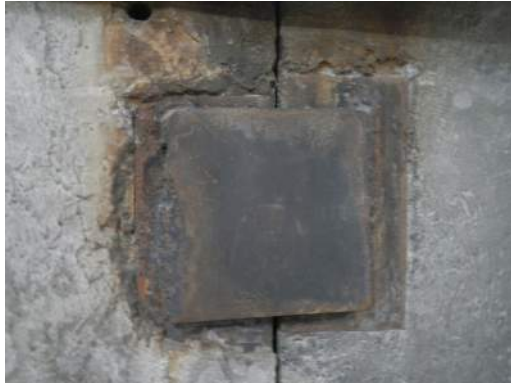
CORROSION IN PANEL CONNECTIONS

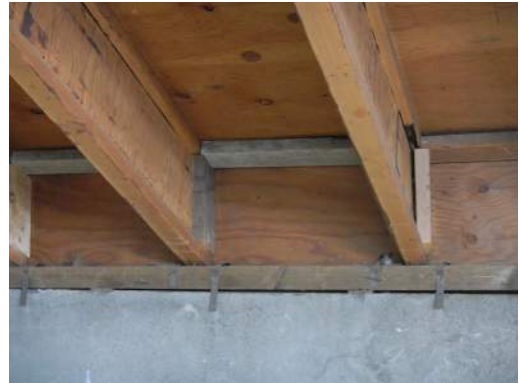
INADEQUATE DIAPHRAGM CONNECTION

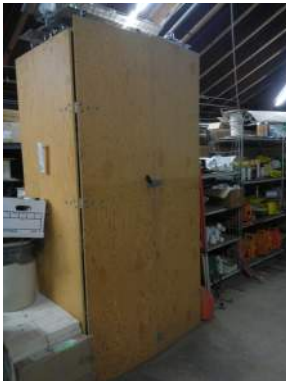
- Fall-prone contents — contents weighing more than 20 pounds whose center of mass is above four feet are not braced. Many shelves are braced, but some are missing braces
- Fall-prone equipment — equipment weighing more than 20 pounds whose center of mass is above four feet is not braced

FALL PRONE CONTENTS

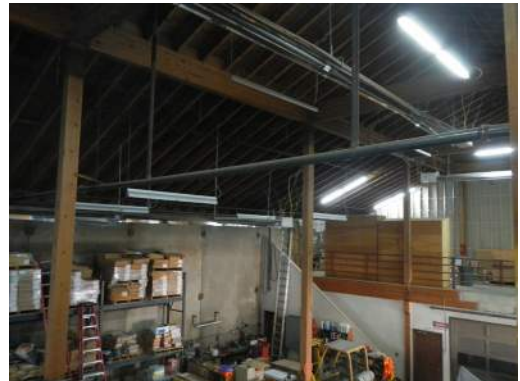
UNBRACED PIPING

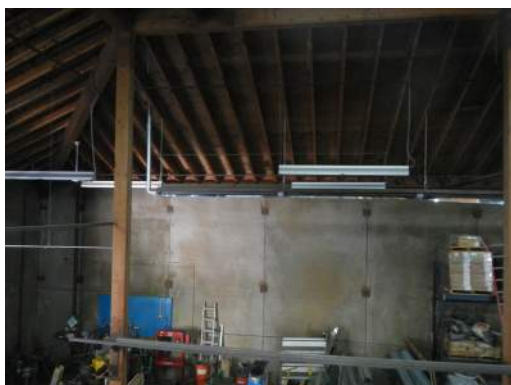
PENDULUM LIGHTING

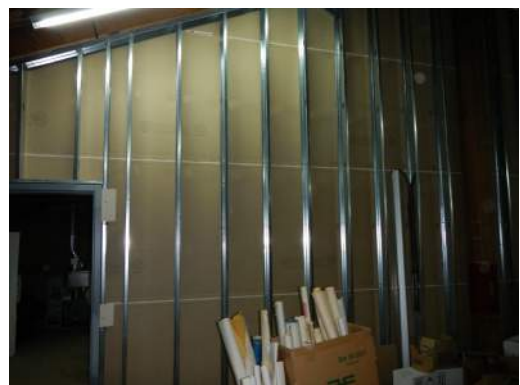
- There is a light gauge metal stud wall in the mezzanine that needs blocking and strapping over the full height and length. We estimate this cost at \$8/sf over the wall surface area

WALL NEEDS BLOCKING AND STRAPPING

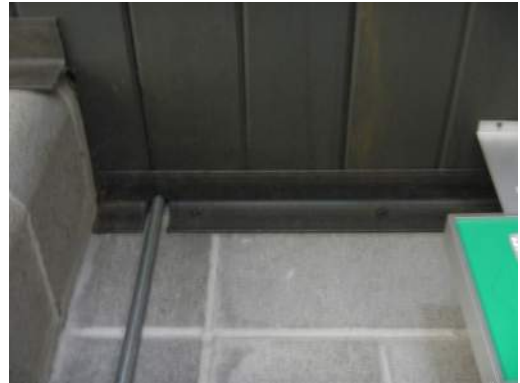
MISSING DIAPHRAGM CONNECTION TO  
LEDGER

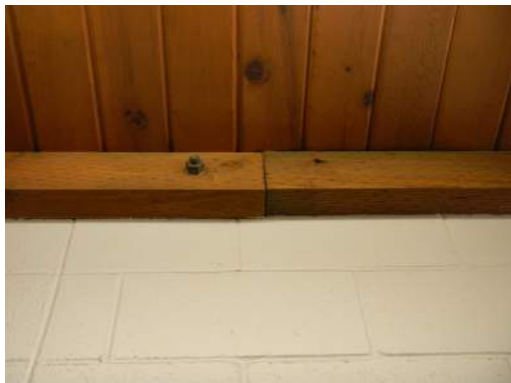
MISSING BOLT IN LEDGER

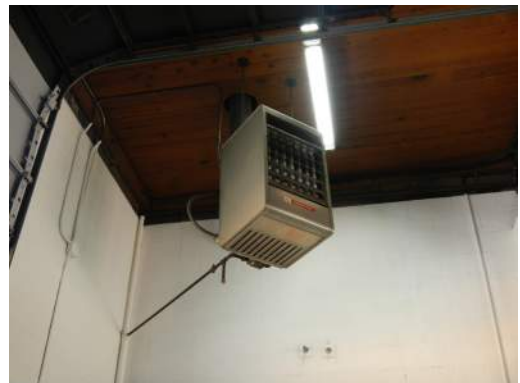
UNBRACED EQUIPMENT

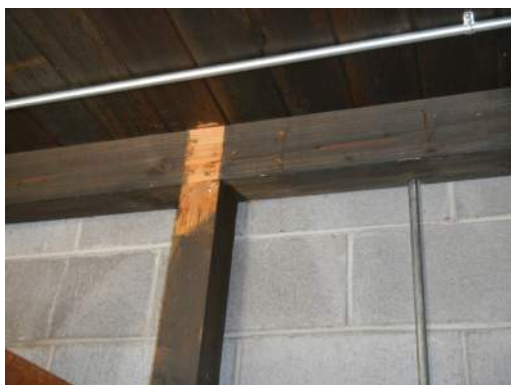
MISSING CONNECTION HARDWARE

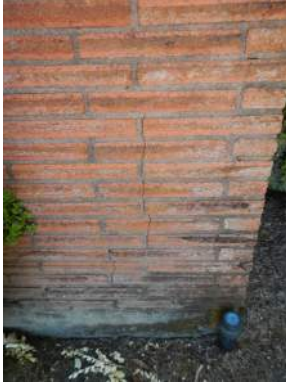
CRACKING IN BRICK VENEER

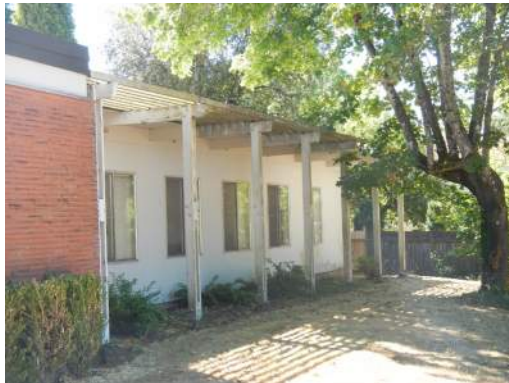
- There is a wood trellis on the west side of the building that has deteriorated and should be removed or replaced. Reference the architectural portion of the cost estimate for extents

DETERIORATED TRELLIS

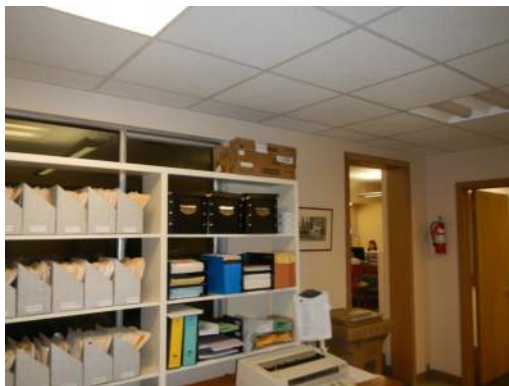
FALL PRONE CONTENTS

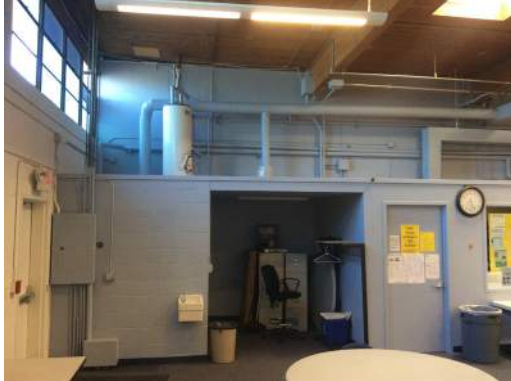
FALL PRONE EQUIPMENT

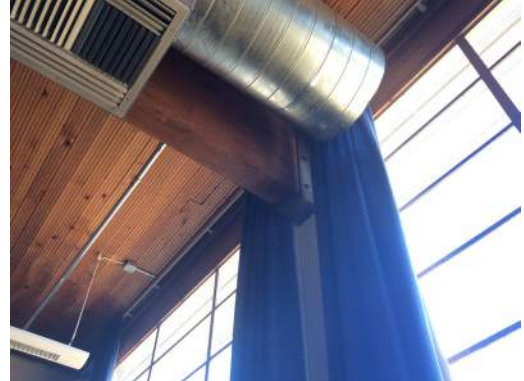
LACK OF SEISMIC CONNECTION AND  
BEAM SUPPORT

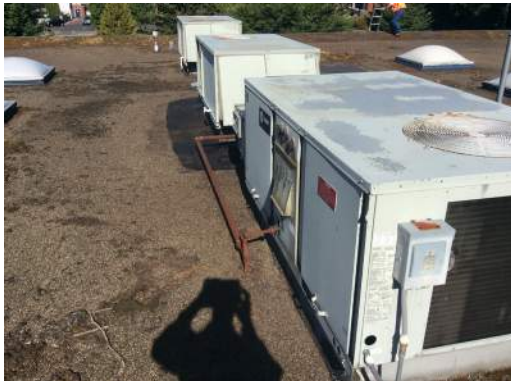
HARD CONNECTED GAS LINES

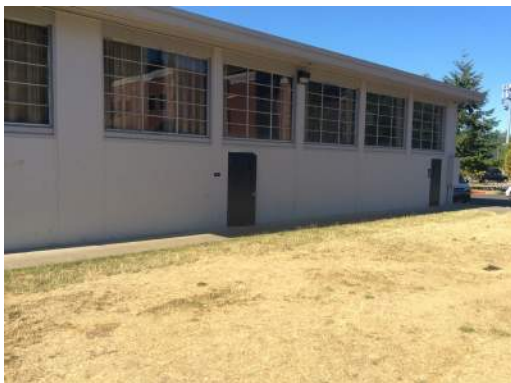
LACK OF LATERAL SUPPORT AT BUILDING END

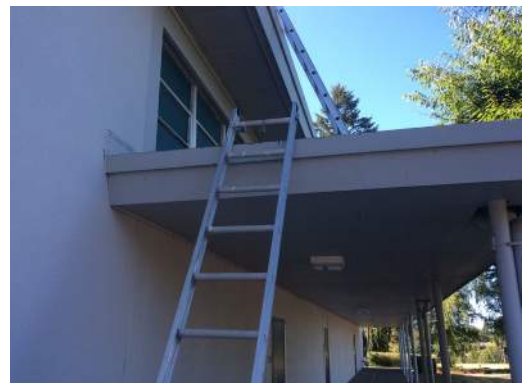
UNKNOWN CANOPY CONNECTION

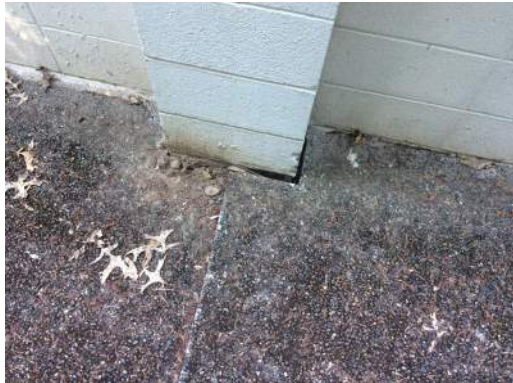
- Approximately 10% of the foundations at CMU columns may have undermined foundations that need to be repaired. Settlement was not apparent at this time. Assume 10 cubic feet of structural grout will need to be formed and poured
- The glulam beams above windows on the north exterior of the locker rooms showed signs of deflection and rotation. They should be reviewed and replaced as needed. Assume 80' of beams will be replaced
- The condition of the roof decking and glulam beams in the pool room and locker room areas should be tested to determine where rot and water damage has occurred. Until additional testing is completed by a third party, assume that 100% of the roof decking and (2) of the approximately 88' glulam beams and their connections will need to be replaced

COLUMN UNDETERMINED

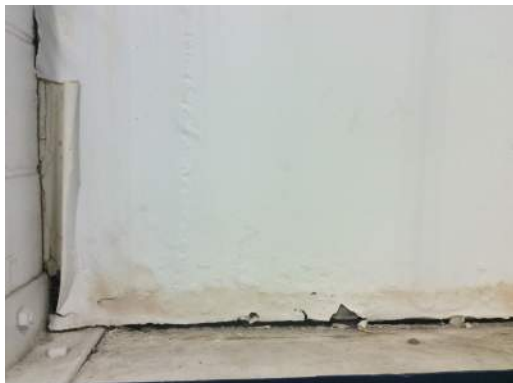
DETERIORATION OF WALL MATERIAL

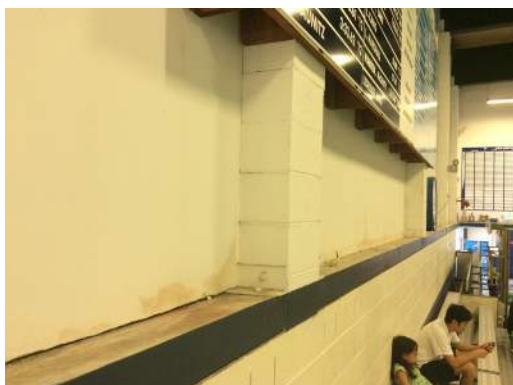
DISCONTINUOUS CMU WALL

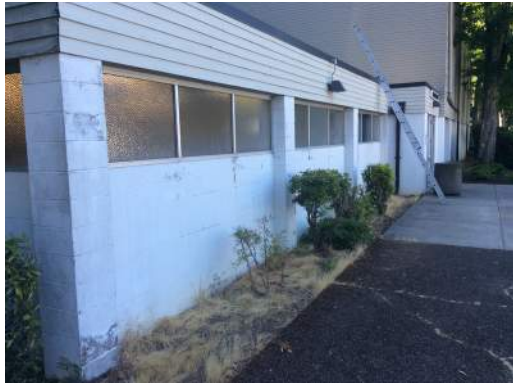
LACK OF LATERAL SUPPORT AT BUILDING SITE

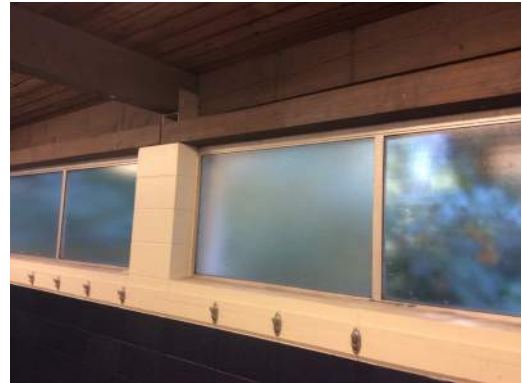
SAGGING AND TWISTING WOOD BEAMS

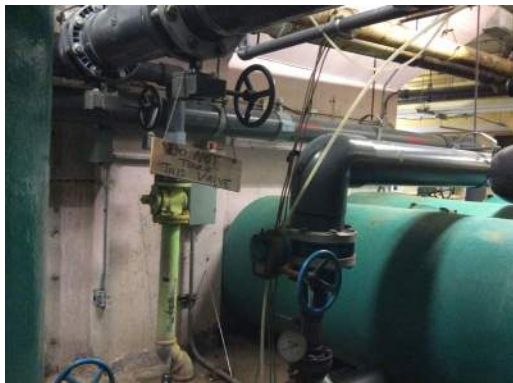
PIPING BRACING

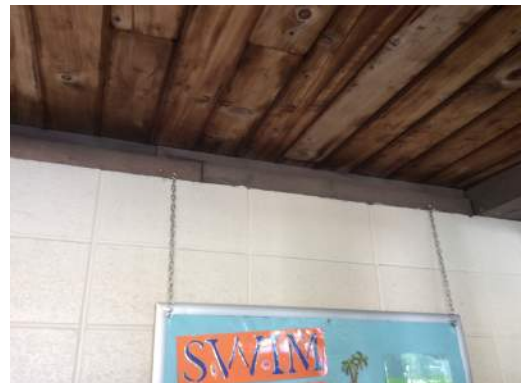
UNKNOWN WOOD DEGRADATION AND  
DIAPHRAGM CONNECTION
